# Manhole Inspection Summary

Manhole # S37KK\_006MH

Insp Date: **3/19/07 10:23 AM**

**Location** Address: **423 NORTH AVE**

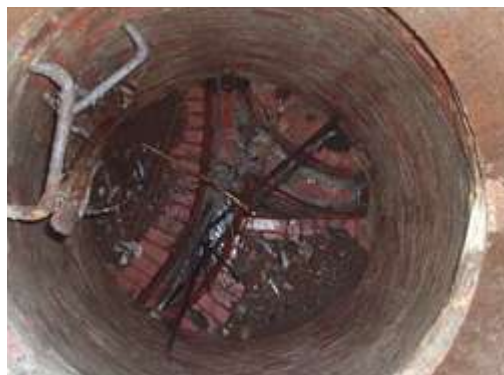
Top View

Corroded steps. Evidence of surcharge - Bench debris. Channel debris.

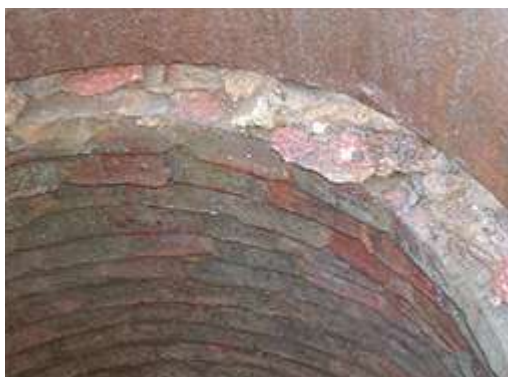
Defect

Frame leaks. Frame offset. Adjustment deterioration and infiltration. Corbel infiltration.

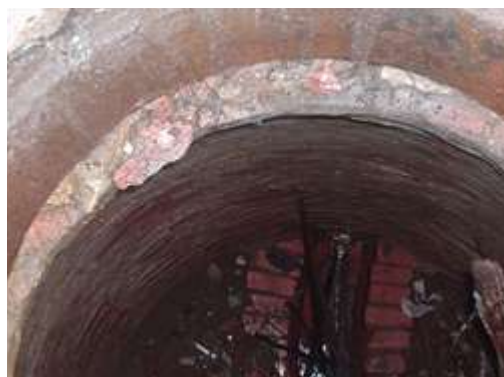
Defect

Frame leaks. Frame offset. Adjustment deterioration and infiltration. Corbel infiltration.

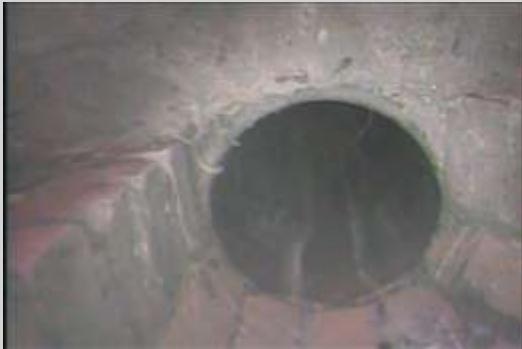
### 8 in. Circular Gravity Sewer Pipe Out @ 12 O'Clock

Invert Depth: **8.08** (ft.) Flow Characteristics: **Slow**

Deposits: ☒ None ☐ Mud ☐ Sludge ☐ Debris ☐ Grease

Infiltration: **None** Pipe Seal Cond: **Unknown**

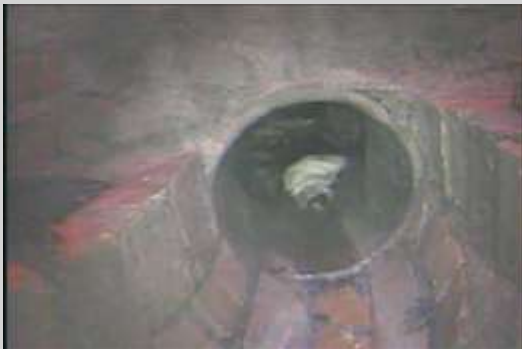
### 8 in. Circular Gravity Sewer Pipe In @ 3 O'Clock

Invert Depth: **8.02** (ft.) Flow Characteristics: **Slow**

Deposits: ☐ None ☒ **Mud** ☐ Sludge ☒ **Debris** ☐ Grease

Silt Depth: **0** (in.) Deposits Extent: **Light**

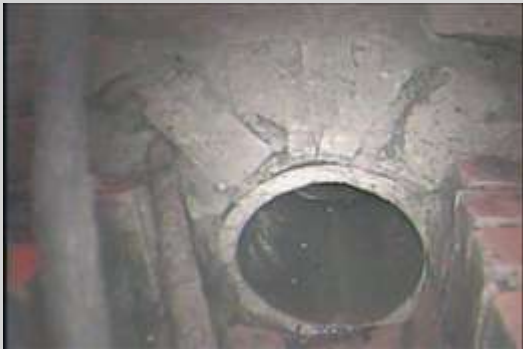
6 in. Circular Gravity Sewer  
Pipe In @ 7 O'Clock

Invert Depth: **7.95** (ft.) Flow Characteristics: **None**

Deposits: ☒ None ☐ Mud ☐ Sludge ☐ Debris ☐ Grease

Infiltration: **None** Pipe Seal Cond: **Unknown**
